DIAGNOSTIC MEASUREMENTS ON POWER TRANSFORMERS

Michael Krüger, Omicron Electronics GmbH, Austria

The paper gives an overview about the latest measuring technologies and contains interesting case studies for successful insulation diagnosis and fault locations in power transformers

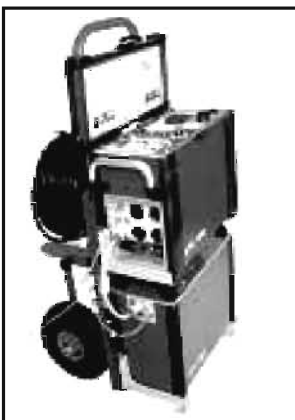
For all impedance and dissipation factor measurements a test system, shown in figure 1 was used. It has a power amplifier, which generates currents and voltages in a frequency range of 15 to 400 Hz [1]. Therefore tests do not have to be made at line frequency only, but can be made in this frequency range. Using frequencies other than 50/60 Hz and the harmonics, precise results can be obtained even in substations with high electromagnetic interference.

Figure 1:
OMICRON CPC100+TD1

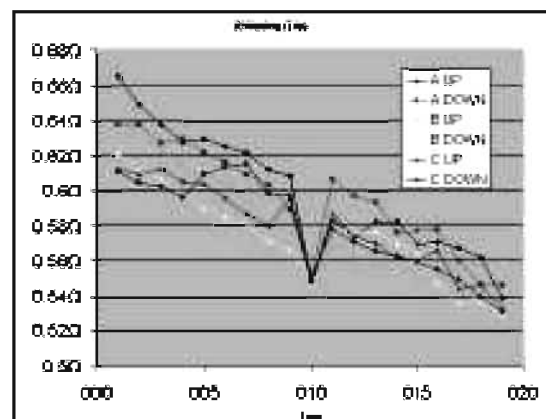
The transformer under test was found to have conspicuously high quantities of gas in the oil, from which the conclusion was drawn of inner overheating. Except for the middle tap all taps showed a significant increase compared to the original measured values. The differences were more than 10 % or, in absolute values, up to 70 mΩ (figure 2).

Figure 2: Winding resistance measurement

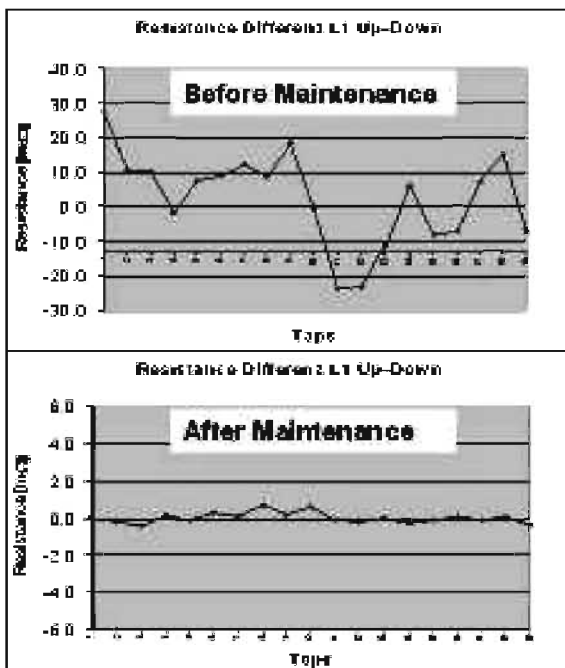
The deviations between switching upwards and switching downwards are likewise clearly significant. This shows that the high contact resistances are actually caused by the switching contacts of the coarse / fine tap selector. No silver-plated contacts were originally used and the copper contact surface was now coated by oil carbon. After a full maintenance of the tap selector, no significant difference to the values measured at the factory in 1954 could be observed (Figure 3). To examine the results in more detail, it is recommended to graph the difference between "UP" and "DOWN" values (Figure 4). The difference before contact maintenance was up to 30 mW £ 5% and after it was below 1 mW £ 0.18%. This is mainly the influence of the fine tap selector contacts.

Figure 4: Difference "UP" - "DOWN"

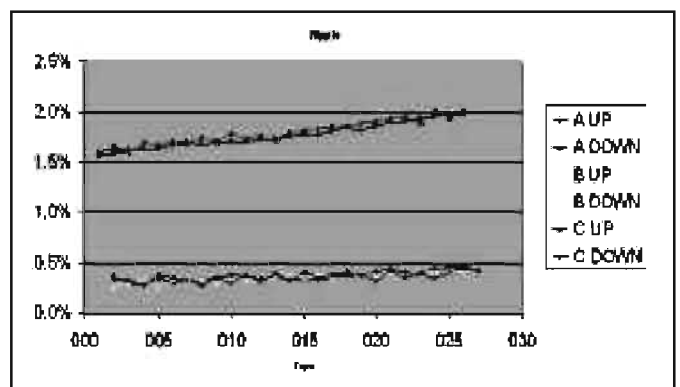
Figure 7 the ripple of aged contacts and

To date, only the static behavior of the contact resistances has been taken into account in maintenance testing. With a dynamic resistance measurement, the dynamic behavior of the diverter switch can be analyzed (Figure 5). For the dynamic resistance measurement, the test current should be as low as possible otherwise short interruptions or bouncing of the diverter switch contacts cannot be detected. In this case, the initiated arc has the effect of shortening the open contacts internally. Comparison to "fingerprint" results, which were taken when the item was in a known (good) condition and to the other phases, allows for an efficient analysis. A glitch detector measures the peak of the ripple ($I_{max}-I_{min}$) and the slope (di/dt) of the measuring current, as these are important criteria for correct switching. If the switching process is interrupted, even for less than 500us, the ripple and the slope of the current change dramatically. Figure 6a shows the ripple and 6b the slope curves of good diverter switch contacts, Figure 7 the ripple of aged contacts and Figure 8 shows one of the aged contacts.

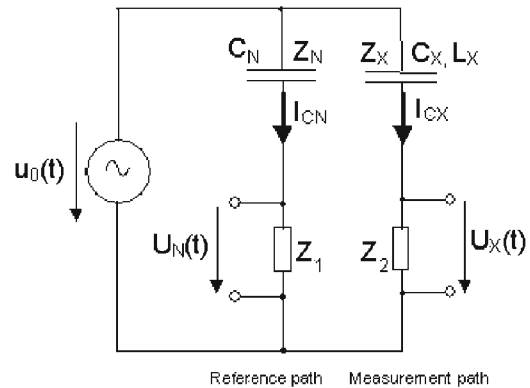
Figure 17: CP TD 1 measuring principle

Figure 17 shows the C-tan d measuring circuit. It can be used for a wide frequency range without balancing a bridge. CN is high precision gas insulated reference capacitor with losses lower than 10-5. A transformer contains a complicated insulation system like it was already discussed for the PDC and FDS measurements. High and low voltage windings have to be insulated to tank and core and against each other. The dissipation factor is an indicator of the oil-paper insulation quality of the single gaps. Degradation of oil, water content and contamination with carbon and other particles increase the dissipation factor. Figure 18 shows a dry winding insulation, figure 19 shows an insulation with a high water content.

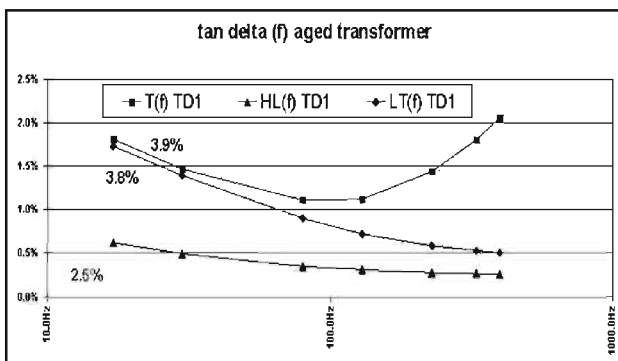
Figure 20 shows the dissipation factor measurement results of a 133 MVA transformer. Although the frequency range is much smaller compared to the FDS measurement, the different water content can be identified clearly.

Figure 20: DF measurement 15 to 400Hz on the 133MVA transformers (figure10)

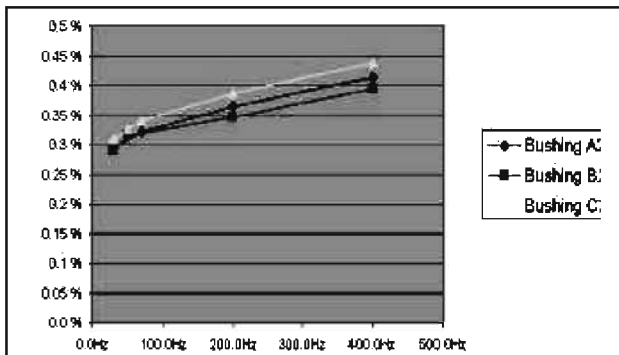
Figure 21: DF of RIP 145 kV bushings (new)

High voltage bushings are critical components of the power transformer and particularly, capacitive high voltage bushings need care and regular tests to avoid sudden failures. Most of these bushings have a measurement tap-point at their base flange and both the capacitance between this tap and the inner conductor (normally called C1) and the capacitance between the tap and ground (normally called C2) can be measured. An increase of C1 indicates partial breakdowns of the internal layers. To determine bushing losses, dissipation factor tests are also performed. Most of bushing failures may be attributed to moisture ingress. As already shown with the winding-to-winding insulation, analysis of bushing insulation is much more detailed when frequency sweeps are performed. In Figure 21 the DF of new resin impregnated paper (RIP) bushings can be seen. All bushings show the same behavior. Figure 22 shows the results of resin bonded paper (RBP) bushings from 1971 in a very good condition. Figure 23 and 24 show a measurement on a 400kV OIP bushing and the DF measurement results.

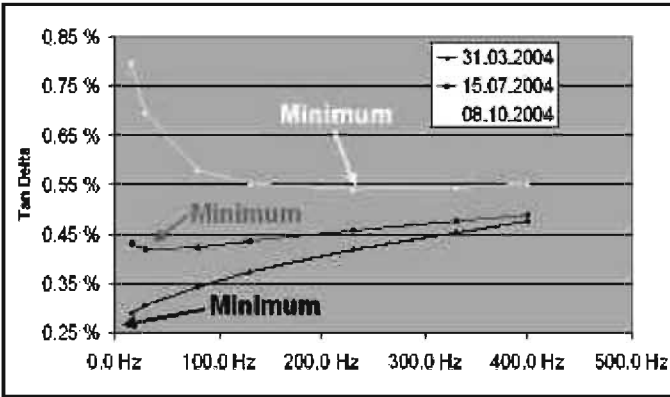
Figures 25 and 26 show a RIP bushing, which was stored outside without any protection. The first measurement was made directly after the bushing was removed from the transformer, the second measurement after three and a half months and the third after more than 7 months. The three curves show how the humidity, which came into the insulation, changes the curves.

Figure 26: RIP bushing stored outside

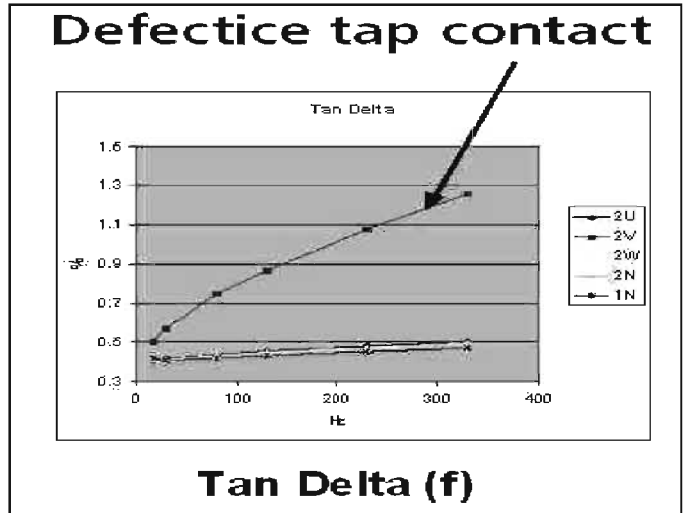
The Figures 29 and 30 show a bushing with a defective contact between the measurement tap and the outside capacitive layer. The DF increases with the frequency nearly linearly. This behavior equals a serial circuit diagram of an ideal capacitance and a resistance. Figure 32 shows a typical curve of such a bad contact over the test voltage. With higher voltages the DF decreases due to the lower contact resistance. This can cause total breakdowns due to the local heat development.

Figure 29: Defective tap contact DF (f)

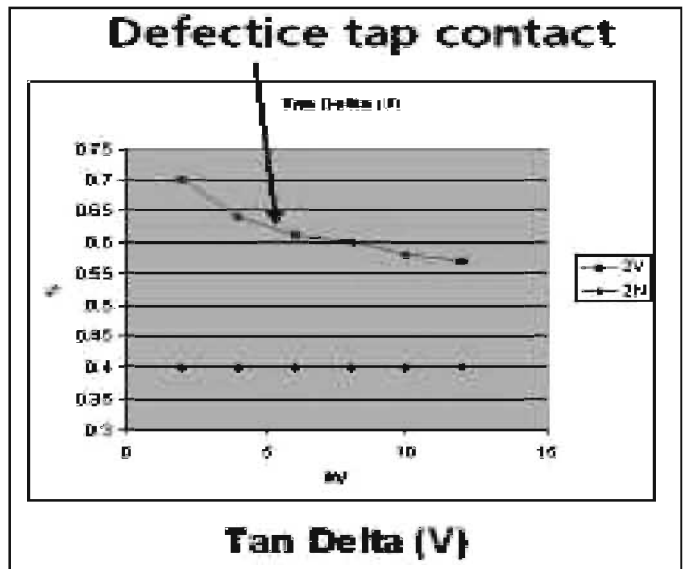
Figure 30: Defective tap contact DF (U)

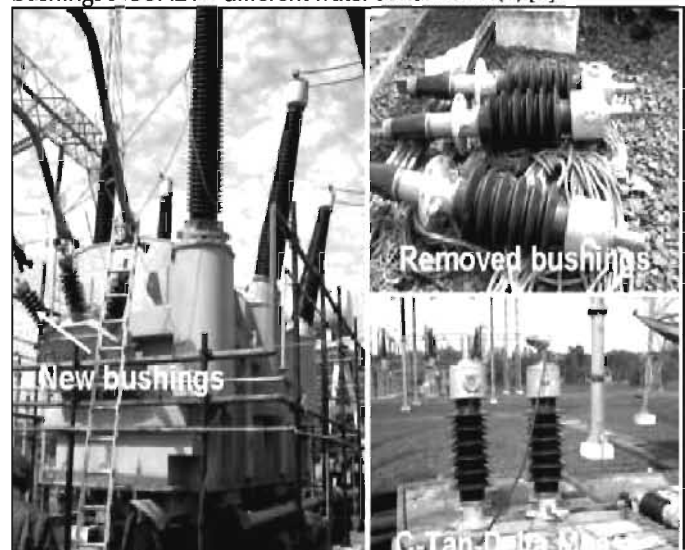
33kV OIP bushings are shown in figure 31. The bushings were dismantled from the transformer because their dissipation factor was very high at high temperatures. Figure 32 shows the DF of OIP bushings at 50Hz for different water contents as f(T) [2].

Figure 31: DF measurement on 33kV OIP bushings

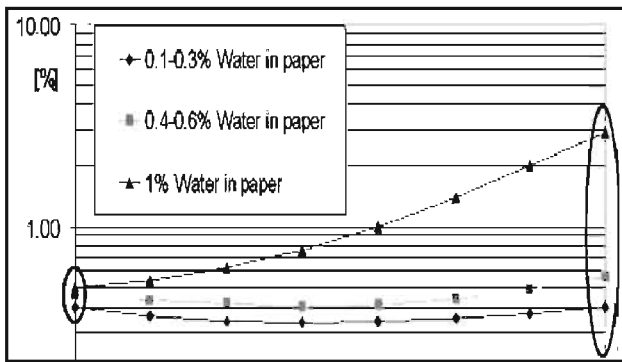
Figure 32

The dissipation factor is in the same order for lower temperatures, whereas the different water contents are well indicated at higher temperatures. The three wet replaced bushings and the three new ones in the transformer were measured again at 30°C from 15 to 400Hz. The results are shown in figure 33.

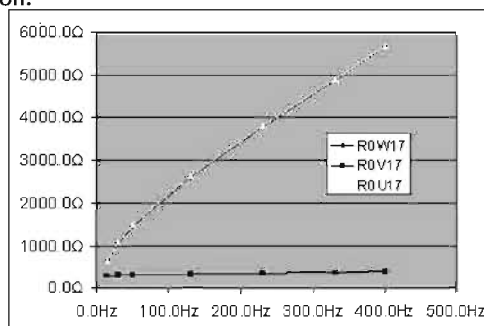
Figure 35a: Resistance of no-load impedance R0 (f)

The no-load impedance was measured from 15 to 400 Hz (figure 35). The V phase showed a totally different behavior, particularly for higher frequencies. Also the excitation current was about eight times higher in the V phase than in U and W phases. This is a clear indication for shorted turns. Figure 36 shows the Frequency Response Analysis (FRA) results. Here also the V phase was totally different from U and W. In the lower frequency range between 50 Hz and 5 kHz the damping is much lower in V compared to U and W. The behavior is similar to a transformer with a short circuited winding on the same limb. A high voltage withstand test combined with a Partial Discharge (PD) measurement showed charges up to 4.5 nC at very low test voltages (figure 37). A complete breakdown occurred at a test voltage of 2 kV. The transformer was opened and the fault was obvious (figures 38 and 39). The clamping screws had been getting loose and touched the core. Due to high eddy currents the local heat melted the screws. Some drops of the melt fall down into the HV winding and shorted two turns.

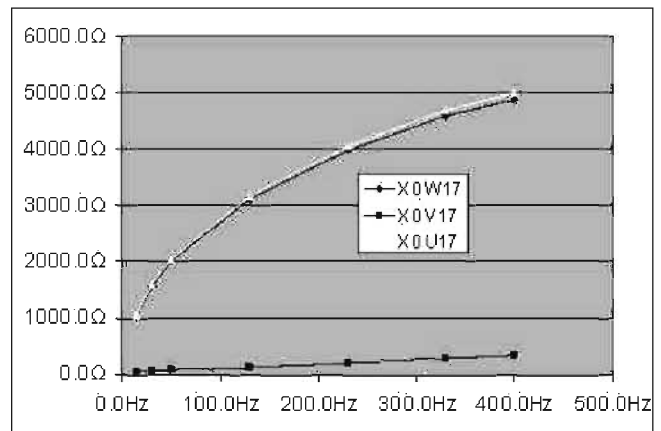
Figure 35b: Reactance of no-load impedance X0 (f)

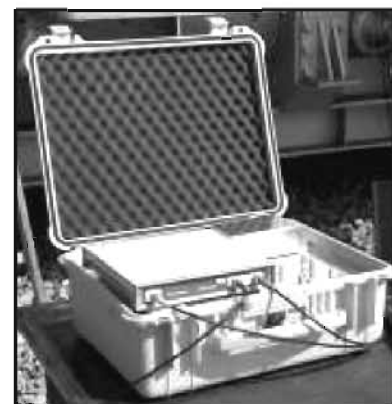
Figure 36: FRA measurement with OMICRON FRAnalyzer

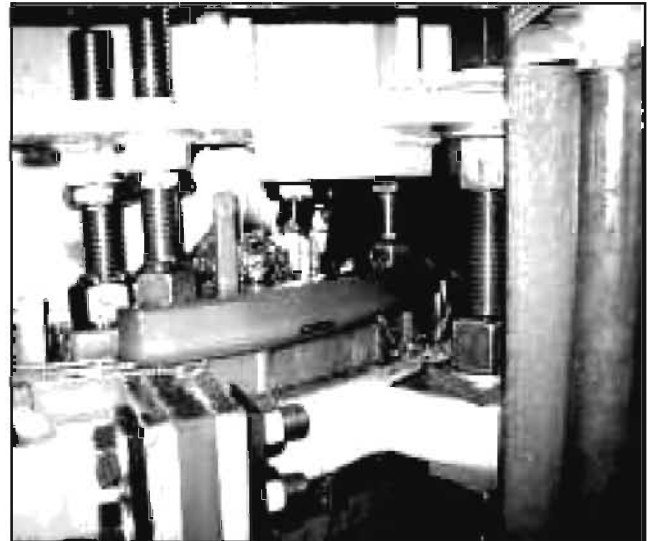
Figure 39: Melted screws were falling into the HV winding and short circuited turns
